FOREST LAKE COMMUNITY SYSTEM PUMPHOUSE

GEOTECHNICAL ENGINEERING REPORT

**Re: Geotechnical Engineering Report
Forest Lake Community System Pumphouse
Forest Lake, Arizona**

Forest Lake Community System Pumphouse
WSP Project # US0036668.2932

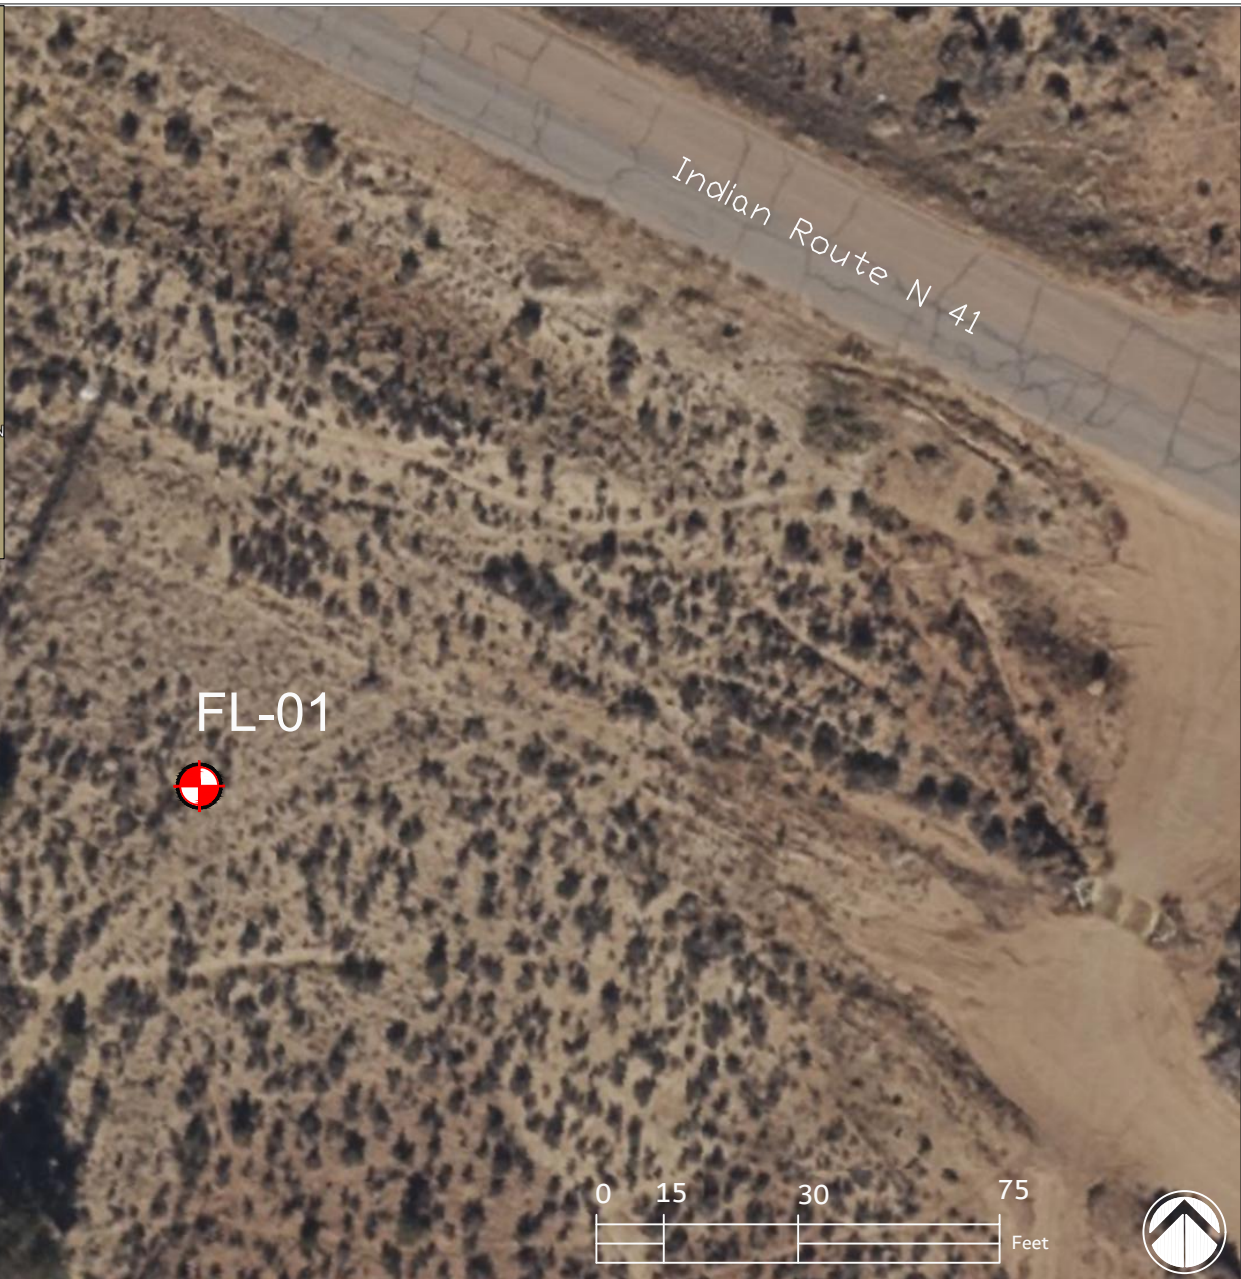
REV. NO.: 1
 DATE: 04/04/25
 PROJECT NO: US0036668.2932
 CONTRACT NO: N/A
 FIGURE NO: 1

LEGEND
FL-01 Completed Boring Number and Approximate Location
 Project Location

TITLE:
Site and Exploration Plan

CONDITIONS	DESCRIPTION
Site layout	See Appendix A, Figures, Site Map and Borehole Location,
Maximum wall loading ¹	2 kips per foot
Maximum allowable settlements	1 inch

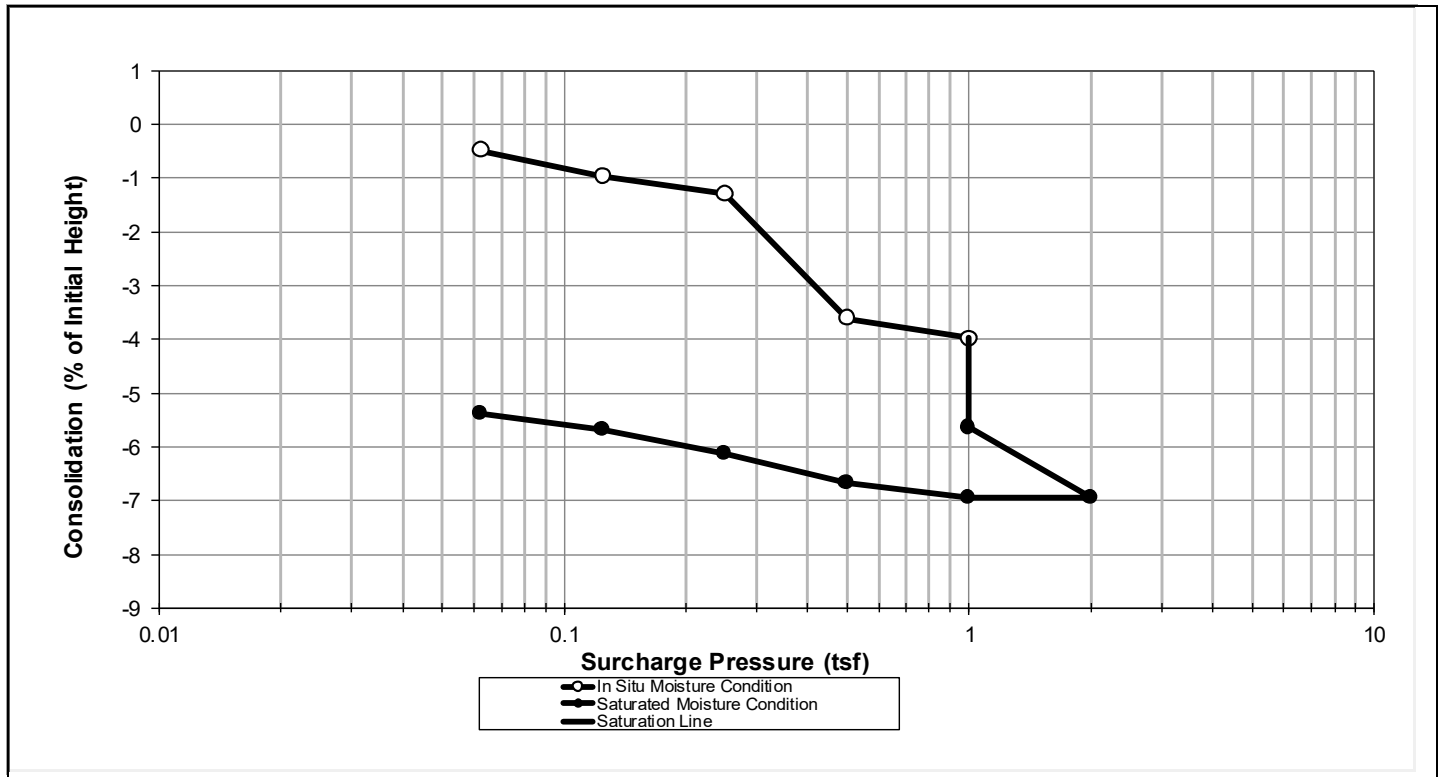
Measurement of Collapse Potential of Soils (ASTM D5333-03)

Initial Volume (cu.in.):	4.60	Final Volume (cu.in.):	4.37
Initial Moisture (%):	4.8%	Final Moisture (%):	17.1%
Initial Dry Density (pcf):	109.1	Final Dry Density (pcf):	114.8
Initial Degree of Saturation:	25%	Final Degree Saturation:	103%
Initial Void Ratio:	0.52	Final Void Ratio:	0.44
Estimated Specific Gravity:	2.651	Saturated at:	1 tsf
Soil Classification:		Consolidation at Max Load:	6.96%

A collapse/swell upon wetting test was performed on a sample from a depth of 5 feet. Results of the collapse and expansion potential upon wetting test is summarized in Table 3. Results of the collapse and expansion test indicate the soil has potential to collapse upon wetting. Laboratory test results are presented in Appendix B.

Sample	Collapse/ expansion	Comment
FL-01 @ 5.0 feet	-1.6%	Collapsed upon wetting

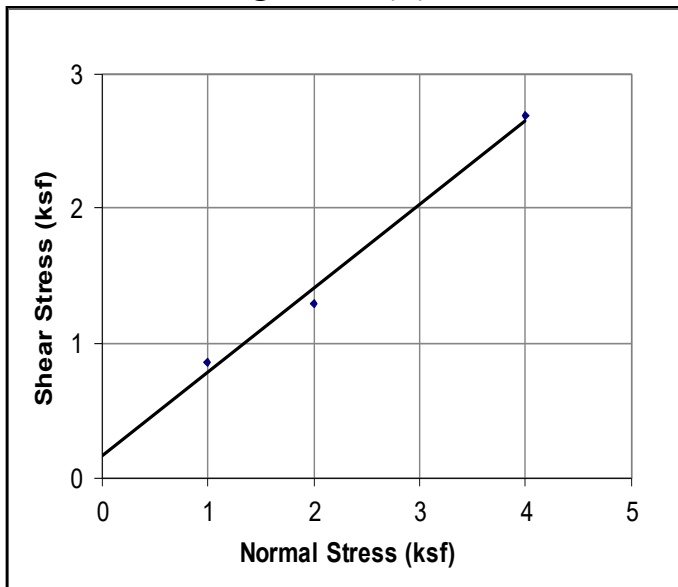
Direct Shear Test of Soils Under Consolidated Drained Conditions (ASTM D3080-11)

1	2	3
Direct Shear Point Number:	1	2	3
Initial Diameter of specimen (in.):	2.42	2.42	2.42
Initial Thickness of specimen (in.):	1.00	1.00	1.00
Dry Mass of Specimen (g):	127.7	123.1	121.3
Initial Moisture (%):	8.0%	7.1%	8.7%
Initial Wet Density (pcf):	114.2	109.2	109.2
Initial Dry Density (pcf):	105.7	101.9	100.4
Final Thickness of specimen (in.)::	0.98	0.98	0.97
Final Moisture (%):	18.3%	17.6%	17.2%
Final Wet Density (pcf):	127.9	121.7	121.9
Final Dry Density (pcf):	108.1	103.5	104.0
Normal Stress (ksf):	1.00	2.00	4.00
Maximum Shearing Stress (ksf):	0.860	1.295	2.691
Vertical Deformation @ Max Shear (in.):	-0.011	-0.008	-0.016
Horizontal Deformation @ Max Shear (in.):	0.150	0.120	0.220

Humboldt Direct Shear Apparatus, Model HM-5760

A relatively undisturbed sample was subjected to direct shear testing. Table 4 summarizes the test results.

Sample	Depth (ft)	Internal Friction Angle, ϕ (deg.)
FL-01	5.0	31.9
