# Navajo Tribal Utility Authority

## HUNTERS POINT COMMUNITY SYSTEM PUMPHOUSE

### GEOTECHNICAL ENGINEERING REPORT

Project No.: US0036792.3454

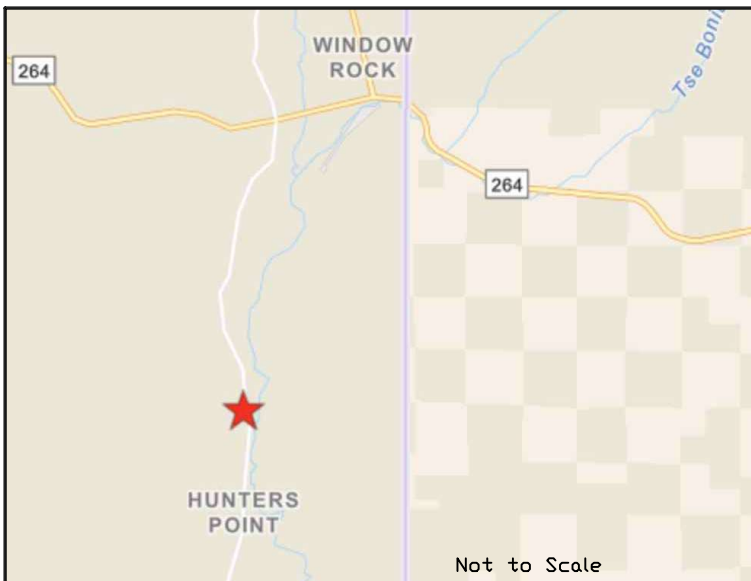
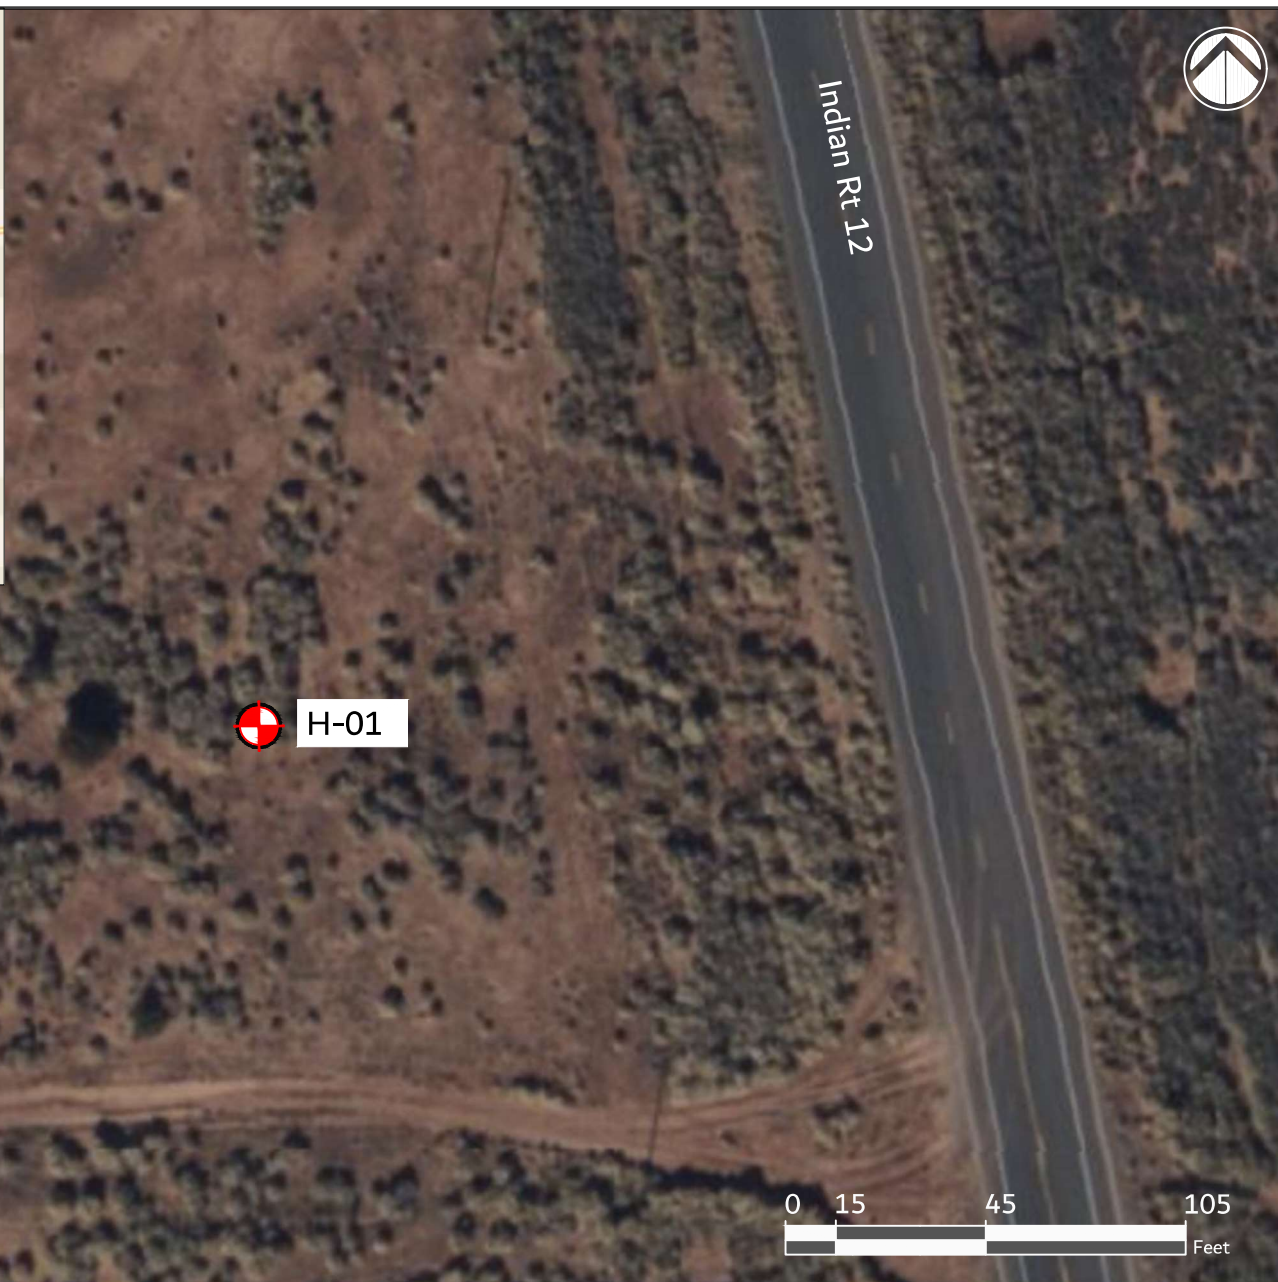
C:\Users\USAJ716450\OneDrive - WSP 0365\Documents\Navajo Reservation Projects\US036792.3452 Hunters Point Community System-Pumphouse\Site and Exploration Plan - Hunters Point Pump House.dwg

<b>CLIENT:</b> NAVAJO TRIBAL UTILITY AUTHORITY	<b>LEGEND</b> Boring Number and Approximate Location

Our geotechnical field study was conducted on May 14, 2025. A single exploratory borehole was drilled to approximately 30 feet below existing grade. A truck mounted Central Mine Equipment Company CME-55 drill rig was equipped using a 7.25-inch outer diameter (O.D.), hollow-stemmed auger to drill. Standard penetration testing (ASTM D 1586) was performed at selected intervals in the subsurface. The soil samples were collected using split-spoon and California modified samplers. The soils were continuously examined, visually classified, and logged by WSP's field geologist. Neither bedrock, cobbles nor water were encountered during the field investigation.

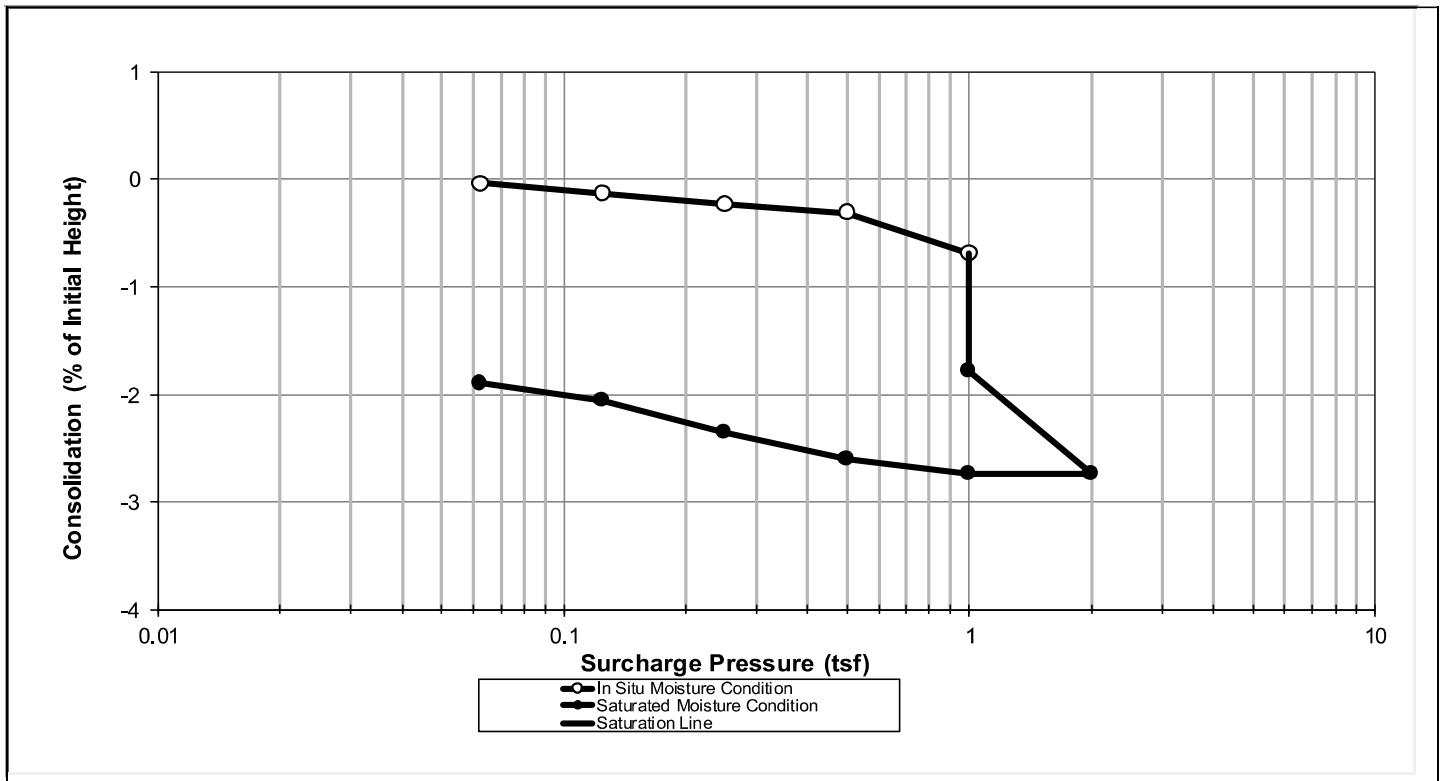
**Measurement of Collapse Potential of Soils (ASTM D5333-03)**

<b>Initial Volume (cu.in.):</b>	4.60	<b>Final Volume (cu.in.):</b>	4.51
<b>Initial Moisture (%):</b>	1.3%	<b>Final Moisture (%):</b>	21.3%
<b>Initial Dry Density (pcf):</b>	101.0	<b>Final Dry Density (pcf):</b>	103.0
<b>Initial Degree of Saturation:</b>	5%	<b>Final Degree Saturation:</b>	94%
<b>Initial Void Ratio:</b>	0.64	<b>Final Void Ratio:</b>	0.61
<b>Estimated Specific Gravity:</b>	2.651	<b>Saturated at:</b>	1 tsf
<b>Soil Classification:</b>		<b>Consolidation at Max Load:</b>	2.73%

Collapse/swell upon wetting tests were performed on samples from depths of 5.0 feet and 10.0 feet. Results of the collapse and expansion potential upon wetting tests are summarized in Table 3. Results of the collapse and expansion test indicate the soil has potential to collapse upon wetting. Laboratory test results are presented in Appendix B.

Sample	Collapse/ expansion	Comment
H-01 @ 5.0 feet	-1.2%	Collapsed upon wetting

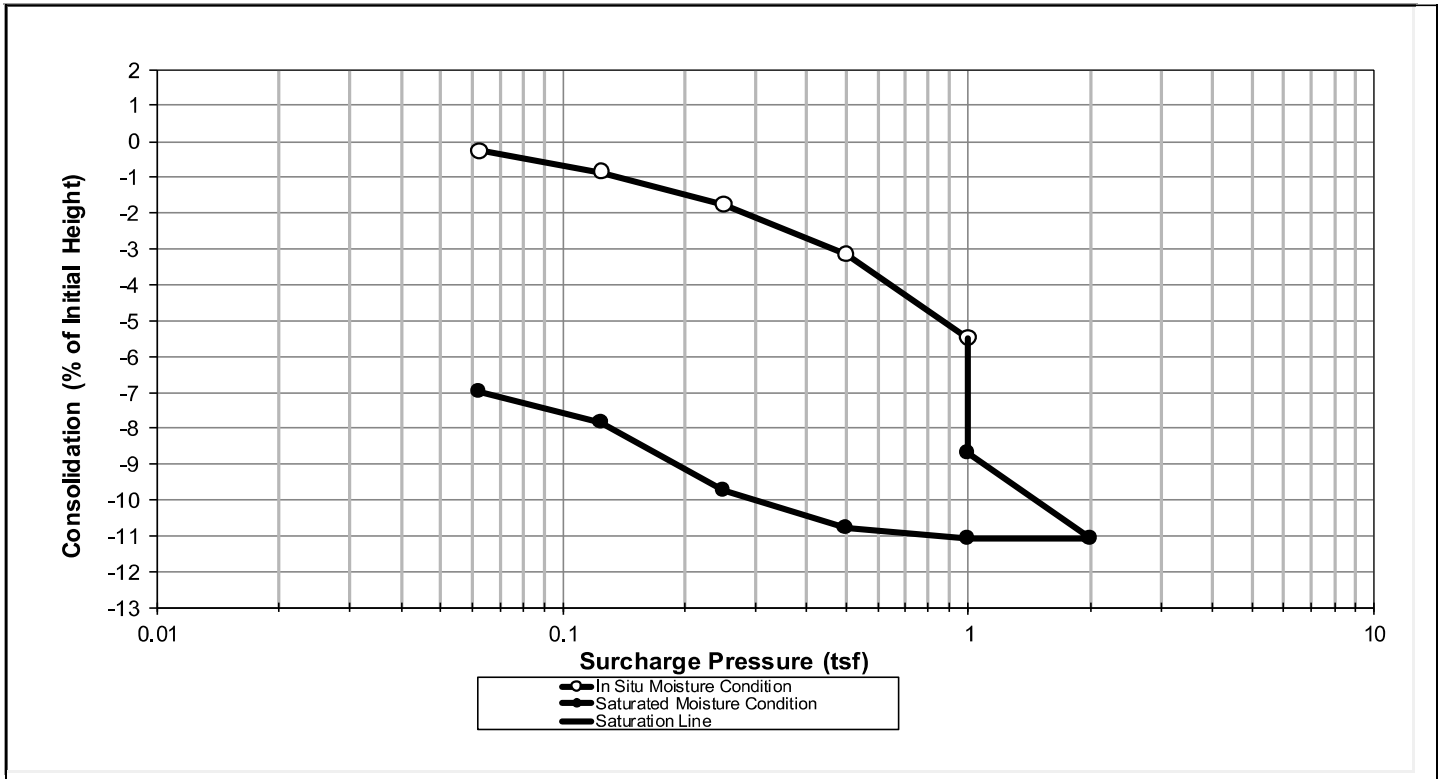
**Measurement of Collapse Potential of Soils (ASTM D5333-03)**

<b>Initial Volume (cu.in.):</b>	4.60	<b>Final Volume (cu.in.):</b>	4.29
<b>Initial Moisture (%):</b>	4.9%	<b>Final Moisture (%):</b>	17.0%
<b>Initial Dry Density (pcf):</b>	108.2	<b>Final Dry Density (pcf):</b>	116.0
<b>Initial Degree of Saturation:</b>	25%	<b>Final Degree Saturation:</b>	107%
<b>Initial Void Ratio:</b>	0.53	<b>Final Void Ratio:</b>	0.43
<b>Estimated Specific Gravity:</b>	2.651	<b>Saturated at:</b>	1 tsf
<b>Soil Classification:</b>		<b>Consolidation at Max Load:</b>	11.08%

H-01 @ 10.0 feet	-3.2%	Collapsed upon wetting
------------------	-------	------------------------

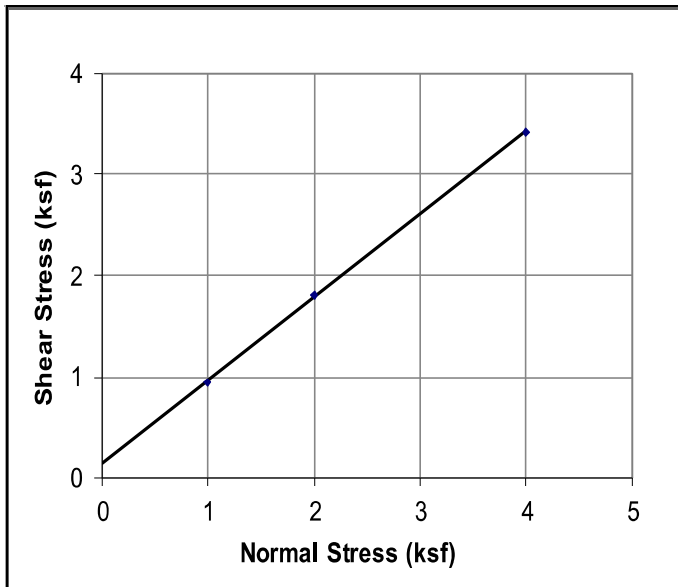
**Direct Shear Test of Soils Under Consolidated Drained Conditions (ASTM D3080-11)**

1	2	3
<b>Direct Shear Point Number:</b>	1	2	3
<b>Initial Diameter of specimen (in.):</b>	2.42	2.42	2.42
<b>Initial Thickness of specimen (in.):</b>	1.00	1.00	1.00
<b>Dry Mass of Specimen (g):</b>	121.2	123.6	116.4
<b>Initial Moisture (%):</b>	5.0%	3.7%	4.9%
<b>Initial Wet Density (pcf):</b>	105.4	106.2	101.1
<b>Initial Dry Density (pcf):</b>	100.4	102.4	96.4
<b>Final Thickness of specimen (in.):</b>	1.01	1.03	1.02
<b>Final Moisture (%):</b>	19.2%	17.1%	17.4%
<b>Final Wet Density (pcf):</b>	119.0	116.1	110.7
<b>Final Dry Density (pcf):</b>	99.8	99.2	94.3
<b>Normal Stress (ksf):</b>	1.00	2.00	4.00
<b>Maximum Shearing Stress (ksf):</b>	0.942	1.808	3.419
<b>Vertical Deformation @ Max Shear (in.):</b>	-0.001	0.009	0.006
<b>Horizontal Deformation @ Max Shear (in.):</b>	0.165	0.090	0.130

Humboldt Direct Shear Apparatus, Model HM-5760

Sample	Depth (ft)	Internal Friction Angle, $\phi$ (deg.)
H-01	5.0	39.4
H-01	10.0	34.6

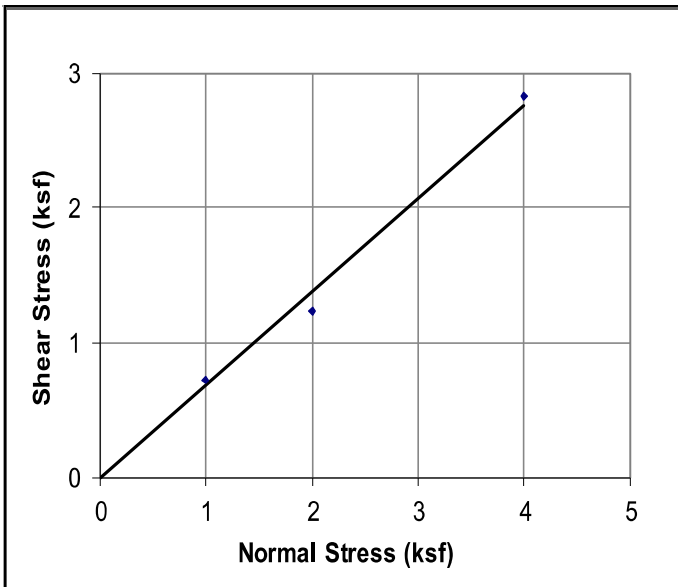
**Direct Shear Test of Soils Under Consolidated Drained Conditions (ASTM D3080-11)**

1	2	3
<b>Direct Shear Point Number:</b>	1	2	3
<b>Initial Diameter of specimen (in.):</b>	2.42	2.42	2.42
<b>Initial Thickness of specimen (in.):</b>	1.00	1.00	1.00
<b>Dry Mass of Specimen (g):</b>	130.5	127.0	122.9
<b>Initial Moisture (%):</b>	7.0%	6.2%	7.5%
<b>Initial Wet Density (pcf):</b>	115.6	111.7	109.4
<b>Initial Dry Density (pcf):</b>	108.1	105.2	101.8
<b>Final Thickness of specimen (in.)::</b>	0.99	0.98	0.93
<b>Final Moisture (%):</b>	17.5%	17.5%	14.3%
<b>Final Wet Density (pcf):</b>	128.4	126.1	124.7
<b>Final Dry Density (pcf):</b>	109.2	107.3	109.1
<b>Normal Stress (ksf):</b>	1.00	2.00	4.00
<b>Maximum Shearing Stress (ksf):</b>	0.722	1.241	2.822
<b>Vertical Deformation @ Max Shear (in.):</b>	-0.004	-0.009	-0.034
<b>Horizontal Deformation @ Max Shear (in.):</b>	0.130	0.150	0.265

Humboldt Direct Shear Apparatus, Model HM-5760
